**Performance Evaluation of Countermeasures Against Rupture and  
Protrusion of Vertically Prestressing Steel Bars in PC Girders**

**Addisu Desalegne Bongor**

**Graduate School of Urban Innovation**

**Yokohama National University**

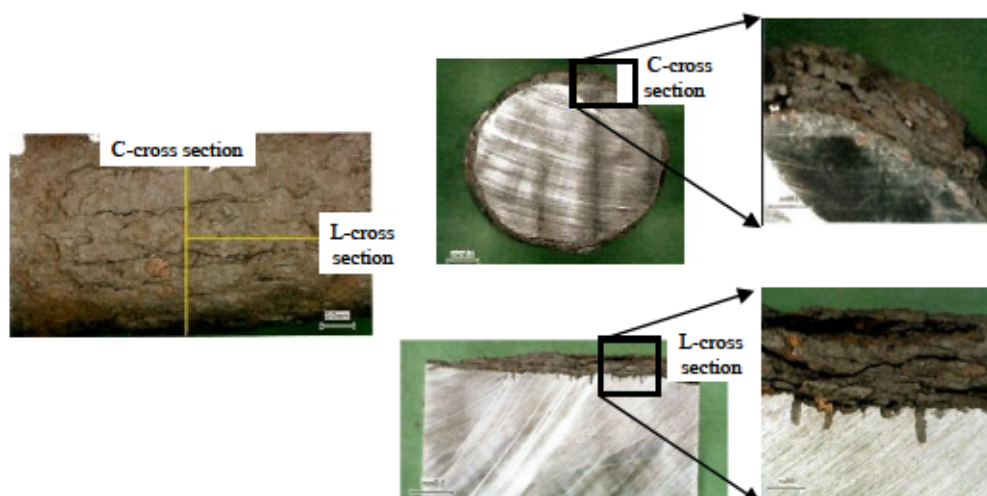
Corrosion products having a thickness of about 2 mm were accumulated near broken portion than the surrounding area as shown in Fig. 1.5.

Fig. 1.5 Corrosion appearance near the PC bar fracture

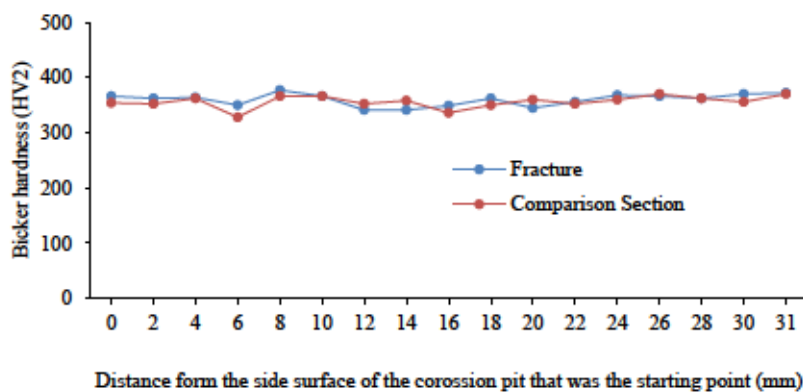
b. **Hardness test:** hardness distribution with micro-Vickers hardness tester at fracture part and base material as a comparison section (7 mm away from fracture part) was measured. As shown in Fig. 1.6 there is little variation of sectional hardness, at fracture part and comparison section.

Fig. 1.6 Vickers hardness distribution curve

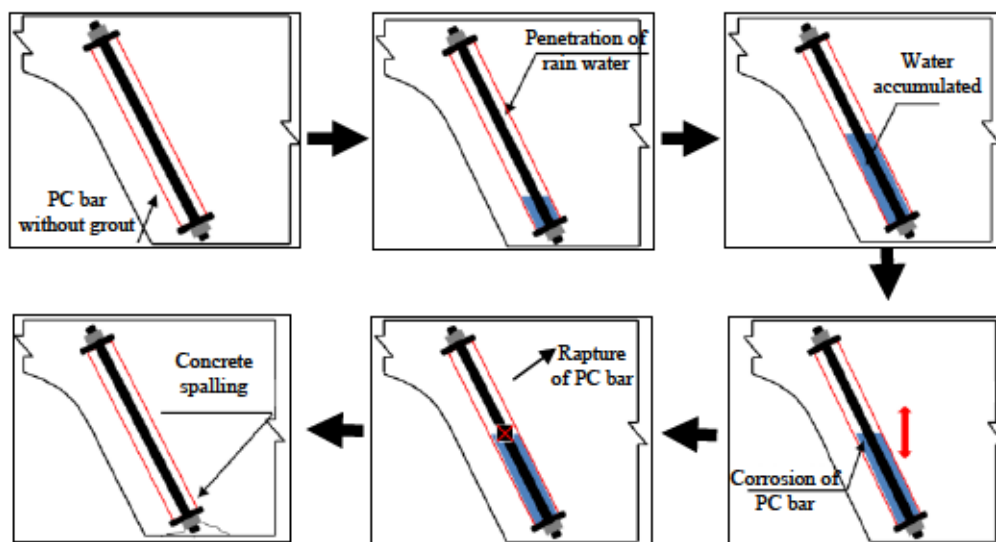
From the investigation results above, it was concluded that the rupture of PC steel bar was brittle and initiated from corrosion pits which were caused by cyclic drying and wetting due to the ingress of rainy water.

Fig. 1.9 Overall damage process

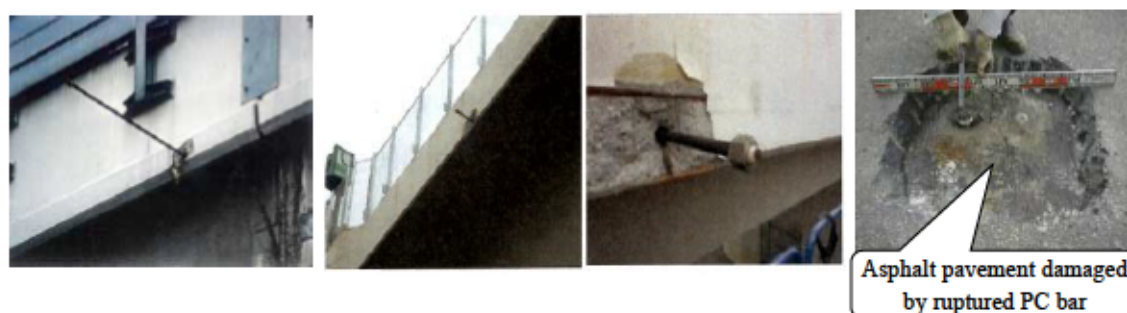
tendons due to insufficient filling of grout inside the sheath [9]. In Japan, it was found that for main cables, about 31% of total 620 investigated tendons showed imperfect grout condition ranging from minor voids to complete loss of grout [23]. In Japan, some existing bridges which were constructed in around 1970 have grout filling shortage considered as a main cause of rupture of PC steel bars, which have been reported several times in the country [36]. Fig. 2.2 shows rupture and protrusion of PC bars in Japan.

Fig. 2.2 Rupture and protrusion of PC bars in Japan [15], [36]

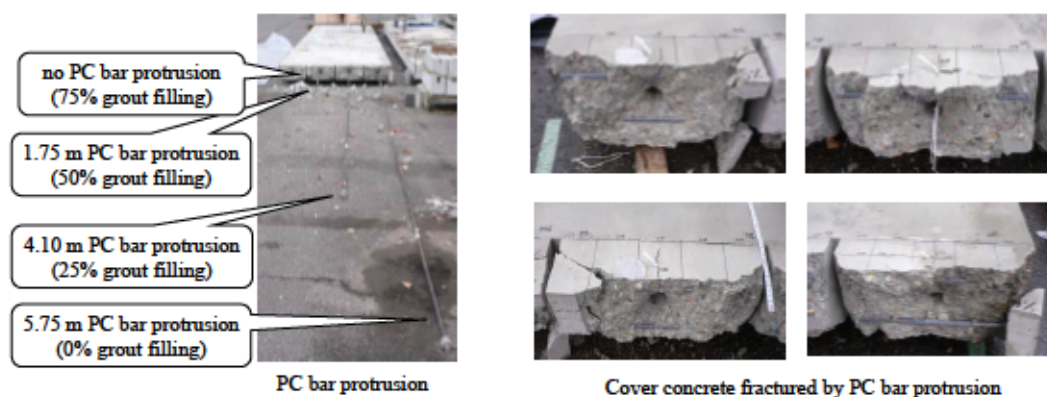
Rupture and protrusion of horizontally prestressing steel bars was investigated [40]. In this investigation, a full-scale floor slab specimen with a PC bar at different grout filling was used (Fig. 2.3). The grout filling levels were 0, 25, 50 and 75%. That was, the PC steel rod length of the unfilled part of the grout was 8, 6, 4, 2 [m] respectively. The PC bar (SBPR 930/1080) and the sheath had  $\phi$  23 mm and  $\phi$  35 mm respectively. The applied prestress force was 780MPa. After cutting of the PC steel rod, protrusion length, the condition of the fracture surface and the damage condition of the cover concrete were recorded. The experimental results after cutting of the PC steel bar are shown in Fig. 2.3. The PC bar and the nut, attached to the end of the PC bar, were protruded, and the bearing plate remained inside the cover concrete. PC bar protrusion for the grout filling levels 0, 25, 50 and 75% were 5.78 m, 4.10 m, 1.78 m and 0.00 m respectively. When the degree of grout filling increased, protrusion of PC bar decreased. In all cases the PC bars destroyed the cover concrete. A cone-shaped cover concrete fracture was observed as shown in Fig. 2.3. In this study, no grout filling in a sheath was considered to simulate the worst cases and to get a safe countermeasure against PC bar protrusion.

Fig. 2.3 The effect of grout filling on PC bar protrusion [40]

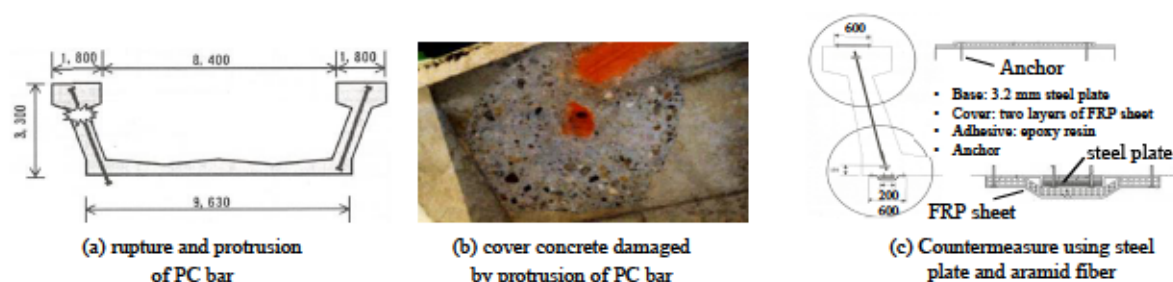
A rupture and protrusion of vertical PC bar was found in East Japan Railway (JR) Company as shown in Fig. 2.6a. The PC bar protruded below the bridge girder and destroyed the cover concrete (Fig. 2.6b). The diameter of the PC bar was  $\phi 29$  mm and the PC bar length was 3.25 m. The PC bar ruptured 1.3 m from the top of the bridge girder. JR East used a conventional type of countermeasures against protrusion of PC bars as shown in Fig. 2.6c.

Fig. 2.6 PC bar protrusions and countermeasures using steel plate and fiber sheets (JR East)

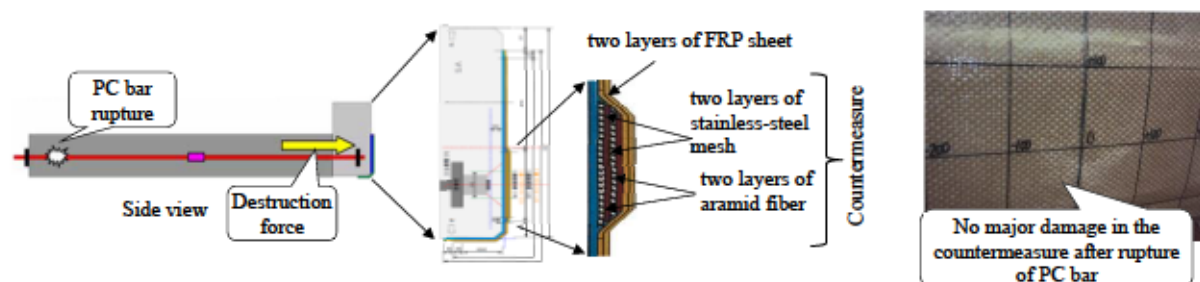
Metropolitan Expressway Company (MEX) experimentally investigated the performance of countermeasure against rupture and protrusion of PC bars. MEX modified the conventional type countermeasure with steel plate and fiber sheets, by replacing the steel plate by a multiple layer of stainless-steel mesh. The target was to reduce construction time by avoiding steel plate and anchor drilling. The countermeasure included two layers of stainless-steel mesh, two layers of aramid fiber and two layers of FRP sheet bonded together by epoxy resin as shown in Fig 2.7. The PC bar was  $\phi 32$  mm. The applied prestressing force was 521 kN. No grout was provided in the sheath. The PC bar ruptured at 10 m from the PC bar head. The result of the experiment indicated that, protrusion of the PC bar was only 20 mm and no major damage was found in the countermeasure. In this study, performance of asphalt pavement was investigated without utilizing stainless-steel mesh, aramid fiber and FRP sheet.

Fig. 2.7 Experiment set up for modified countermeasure [40]

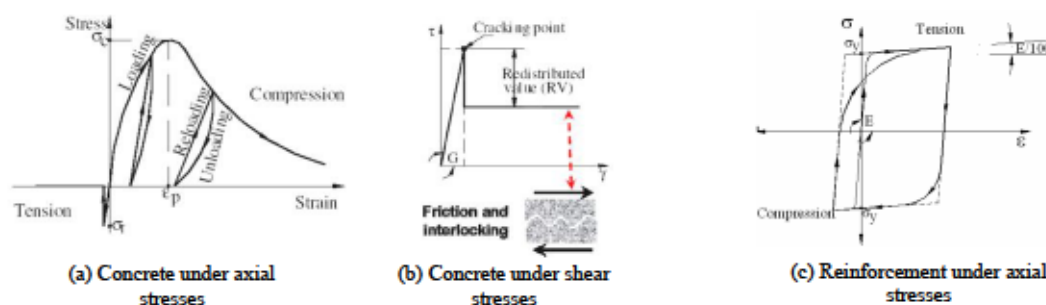
Fig. 2.15 Constitutive models for concrete and reinforcement used in Extreme Loading for Structure (ELS) [75]

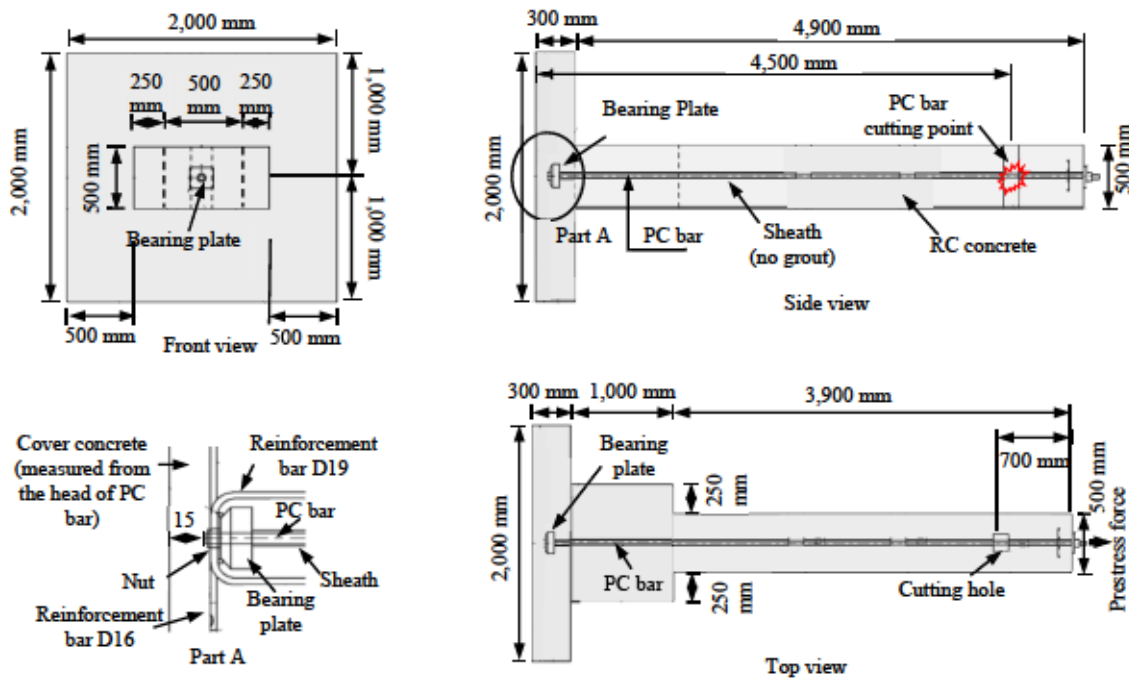
The details of the specimen with 15 mm cover concrete simulating the bottom of a bridge girder is shown in Fig. 3.1. PC bar rupture length was 4.5 m. In MEX, there are very few vertical PC bars longer than 4.5 m. The diameter of the PC bar tendon was  $\phi 32$  mm and that for the sheath was  $\phi 45$  mm. The sheath was not grouted. Cover concrete was 15 mm.

Fig. 3.1 Specimen details with 15 mm cover concrete [1]

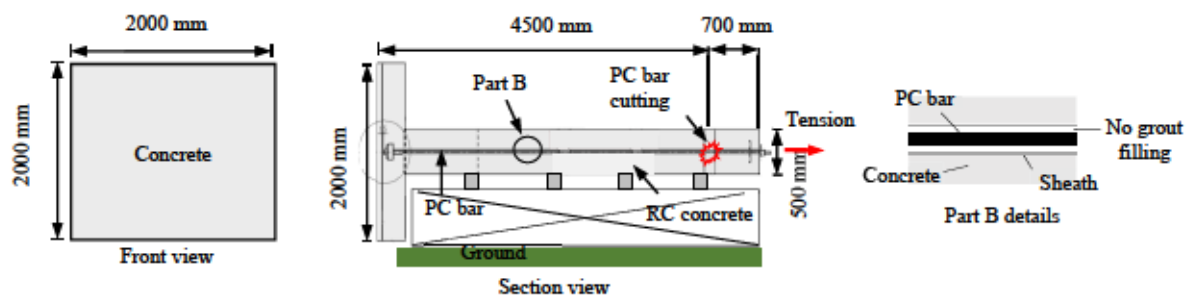
Fig. 3.2 shows the experimental setup. The PC bar was inserted into the sheath. The PC bar had no contact with the sheath during prestressing. The sheath was not grouted. Tension force was applied to the PC bar. The PC bar was cut using a grinder at 4.5 m from the PC bar head. Then, the protrusion of the PC bar and concrete spalling were investigated.

Fig. 3.2 Experimental setup for the specimen with 15 mm cover concrete [1]

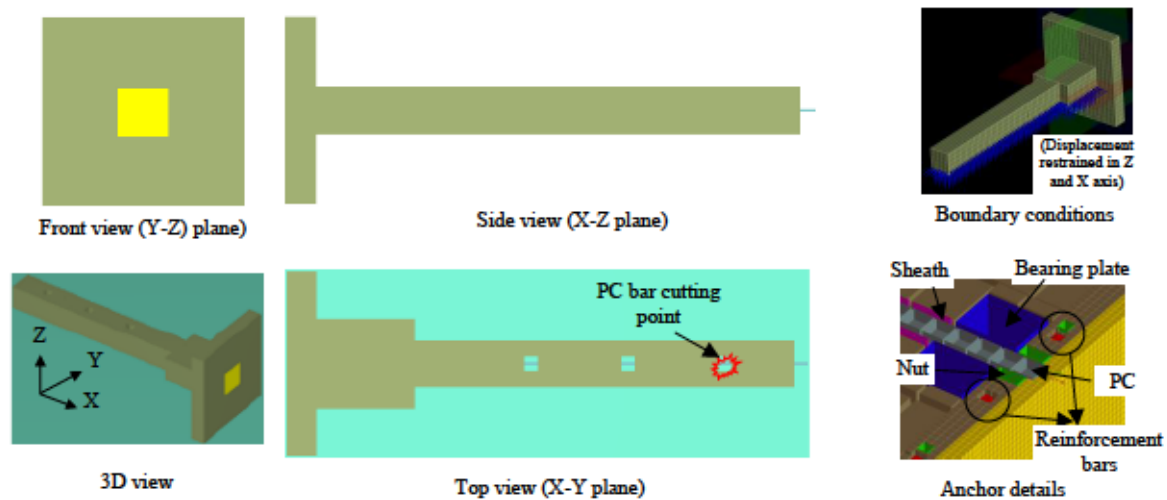
AEM numerical simulation was made for the specimen shown in Fig. 3.1. Geometry and materials of the PC bar, the bearing plate, the nut, and the sheath are shown in Table 3.1. The interface material between the sheath and the PC bar and that between the bearing plate and the PC bar were modeled using “bearing material” (a material that can transfer only compression). On the other hand, the interface material between concrete and other metal materials (the PC bar, the nut, the bearing plate, and the sheath) was modeled as normal concrete (40 MPa compressive strength).

Fig. 3.9 AEM numerical simulation [1]

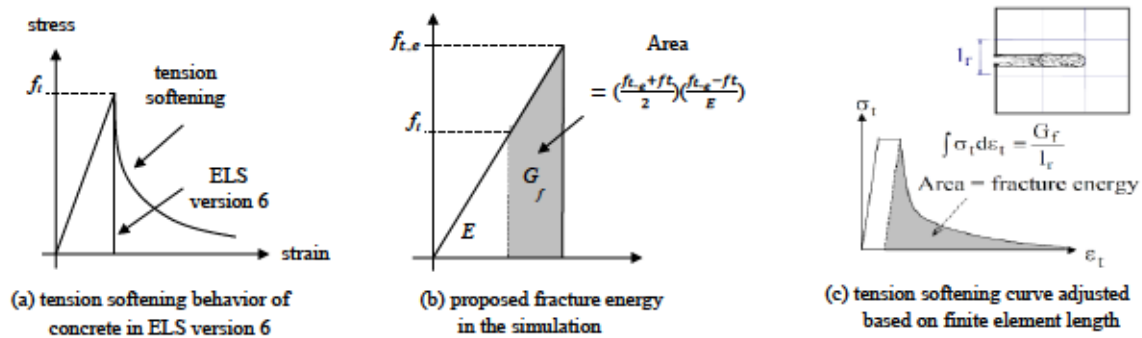
Fig. 3.10 Consideration of fracture energy of concrete in ELS Version-6

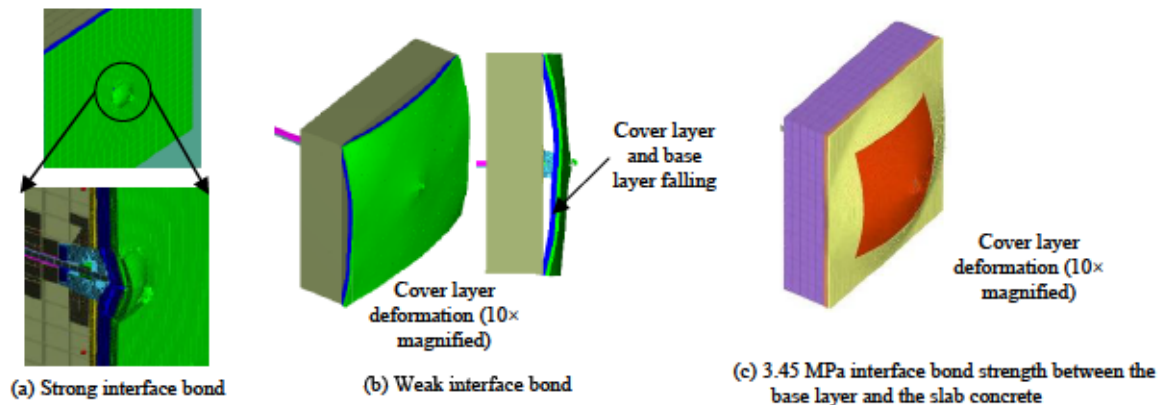
Fig. 4.6 The effects of bond at interface between asphalt base layer and slab concrete on the asphalt pavement deformation and on the failure mode [1]

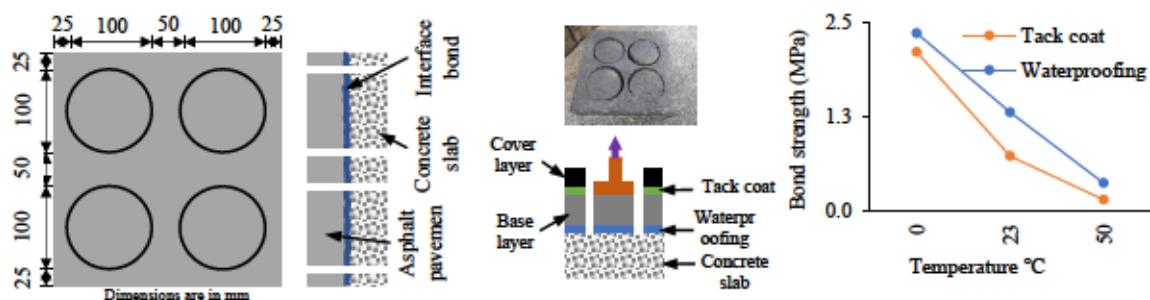
Fig. 4.16 Pull-off adhesion test of tack coat and waterproofing [5]

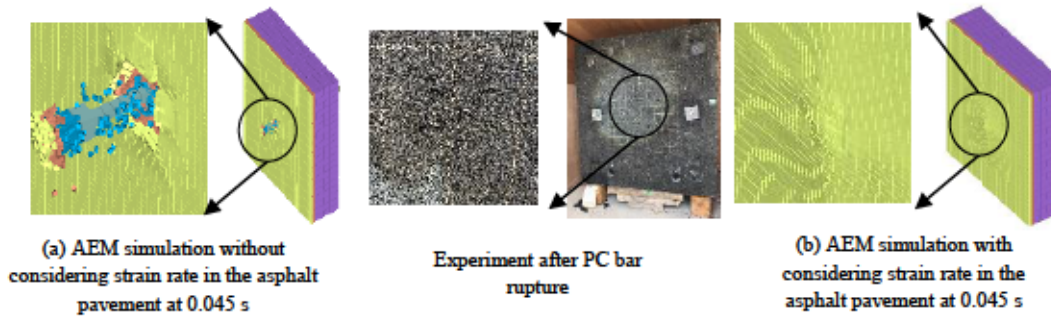
Fig. 4.23 The effect of strain rate in the failure mode of asphalt pavement in the AEM simulation at 50°C

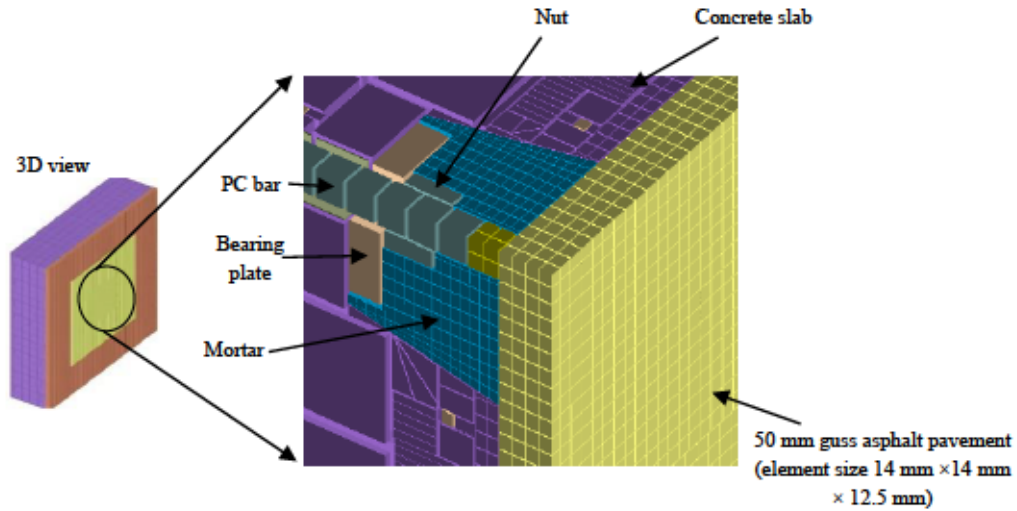
Fig. 4.31 Modeling for AEM numerical simulation considering guss asphalt pavement

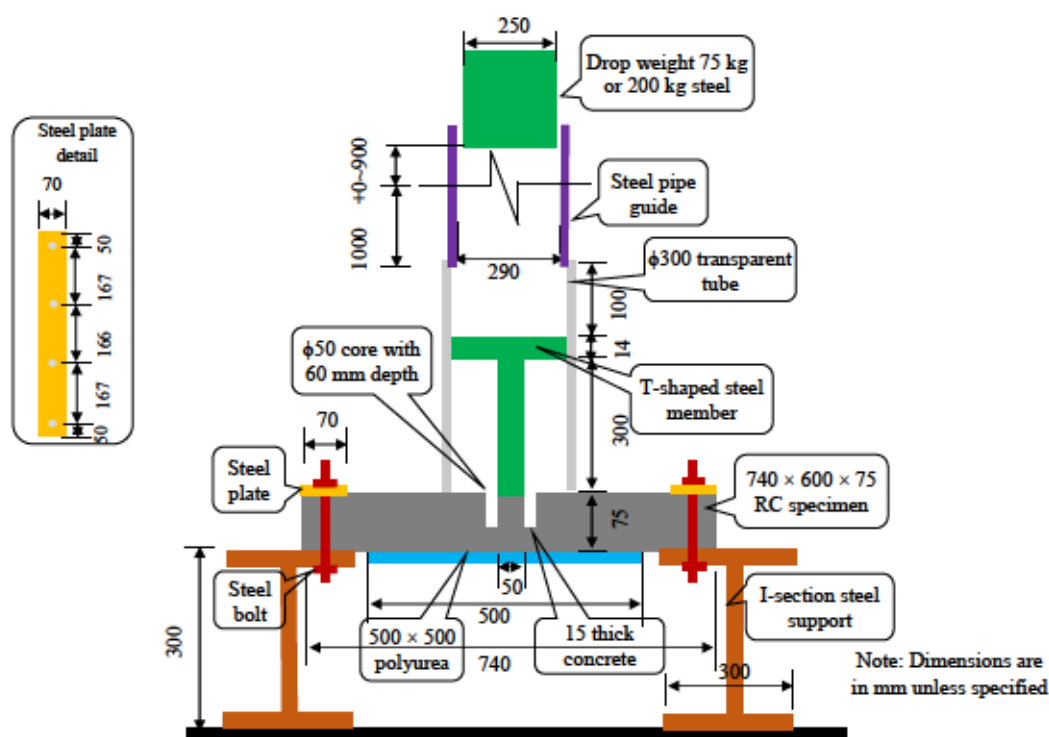
Fig. 5.1 Drop weight test [1]

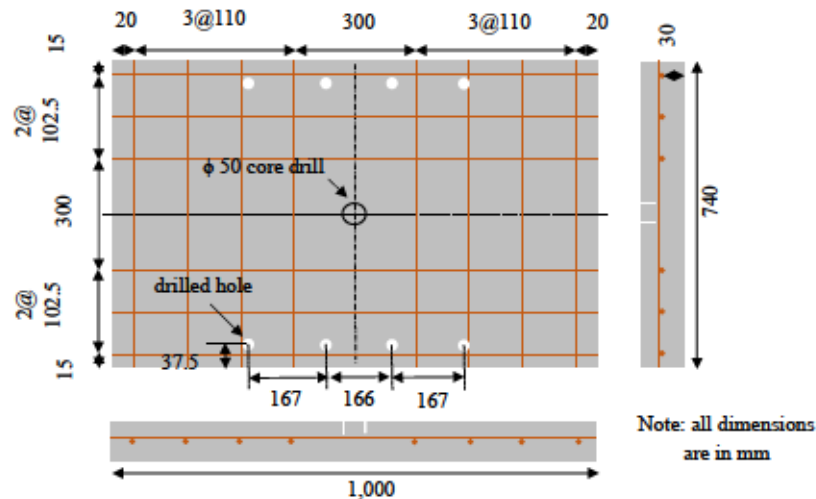
Fig. 6.7 Details of steel fiber reinforced PCM slab [2]

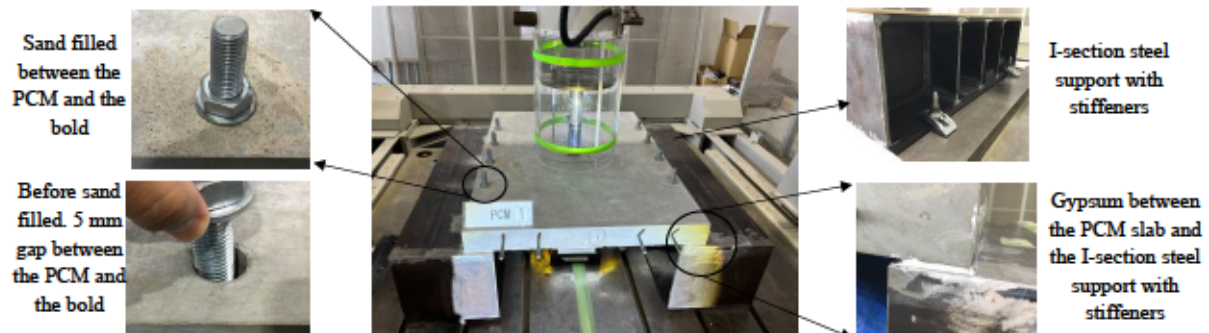
Fig. 6.21 Drop weight impact experiment on the PCM with proposed boundary condition

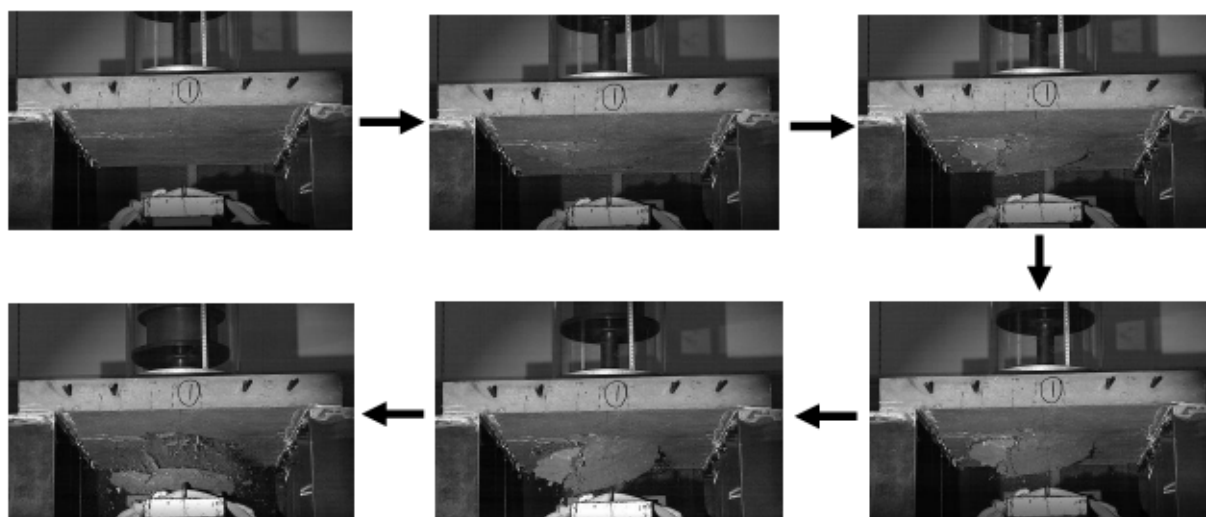
Fig. 6.23 Progressive collapse of PCM punch-out (experiment) using the proposed boundary conditions

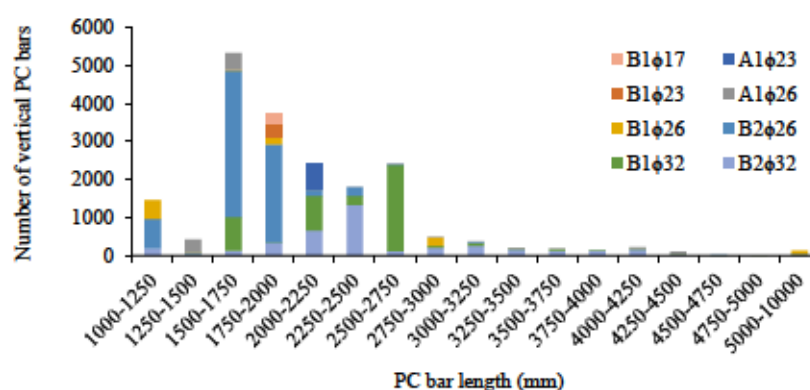
Fig. 7.1 Number of vertical PC bars in MEX (by diameter and length)

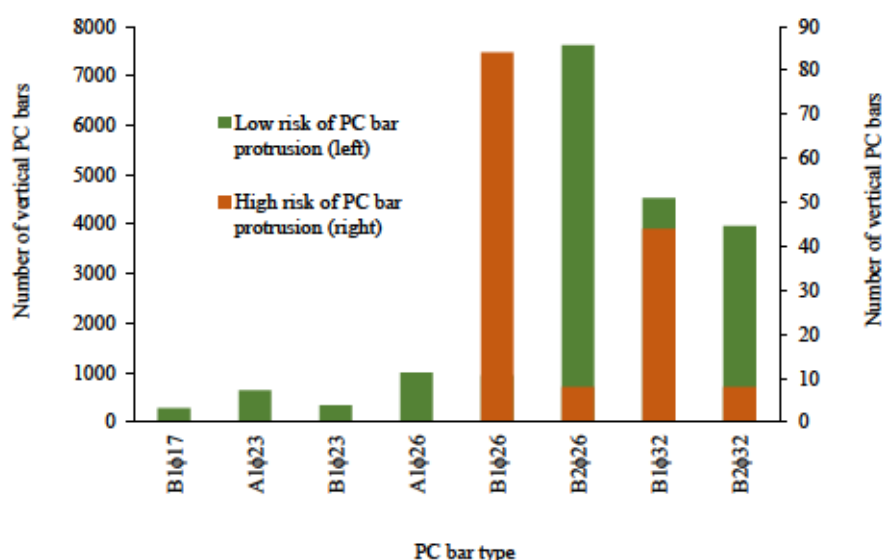
Fig. 7.3 Risk of vertical PC bar protrusion in MEX
