**A STUDY ON PERFORMANCE EVALUATION OF LOCALLY
CORRODED STEEL PLATE GIRDER BRIDGE ENDS**

A Dissertation Submitted in Partial Fulfillment of the
Requirements for the Degree of
Doctor of Philosophy

Department of Civil Engineering
YOKOHAMA NATIONAL UNIVERSITY, JAPAN
September, 2012

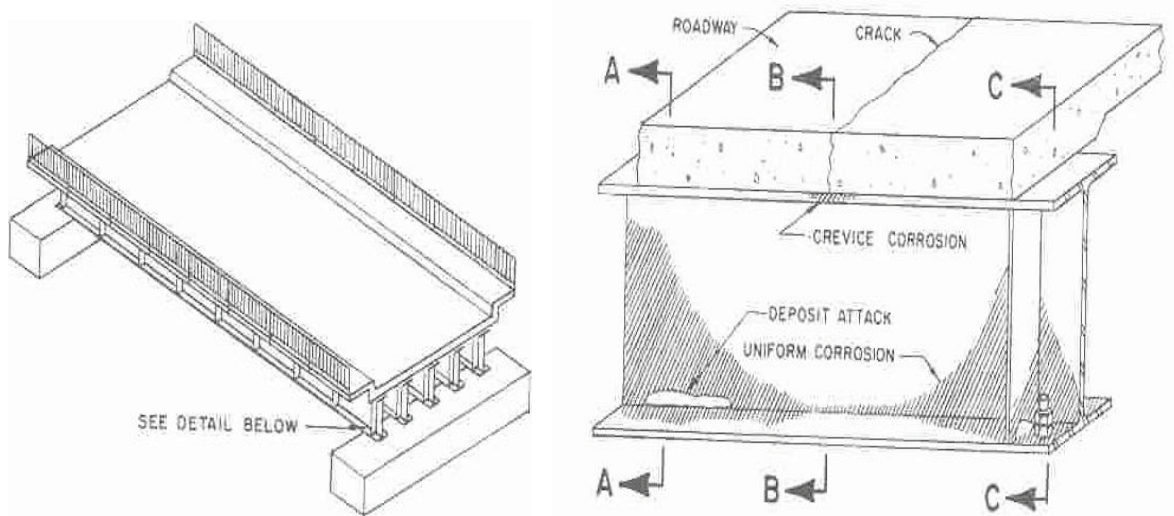
Figure 2.1: Different corrosion types on the steel plate girder

Crevice corrosion occurs where different components of the structure are close, leading to narrow spaces. Normally, this type of the corrosion is observed at the top flanges of plate girders as shown in the Figure 2.1. In such cases water leaks through the cracks in the slab and gather within the cracks above the top surface of the flanges

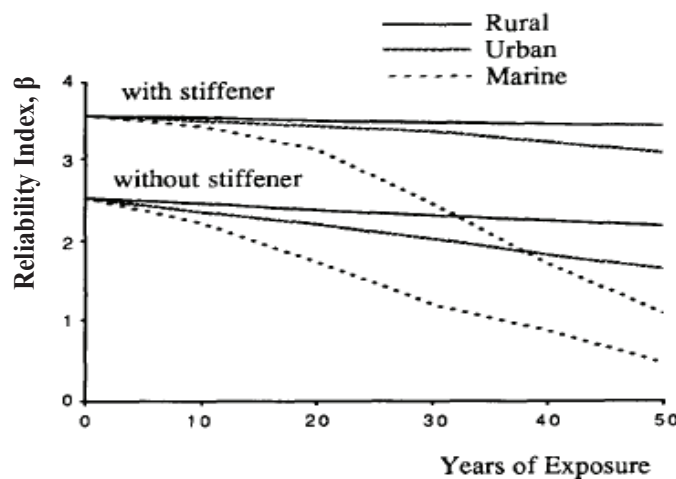
Figure 2.2: Environmental effect on steel bridges corrosion (Kayser 1989)

Corrosion rate is highly influenced by the environment, *i.e.* the amount of moisture in the air and the presence of salt thus, the geographic location play a vital role in planning the maintenance of steel bridges. Figure 2.2 shows that steel bridges near marine environment have more probability to corrode with the years of exposure as compared to the rural and urban environment. It has also been observed that the rate of corrosion can be different for different girders. For example, in highway overpasses, girders are exposed to a mixture of salt, snow, and water splashed by trucks. The highest concentration of this aggressive medium is on the exterior girder, and the concentration of salt and/or water decreases in the direction of traffic.

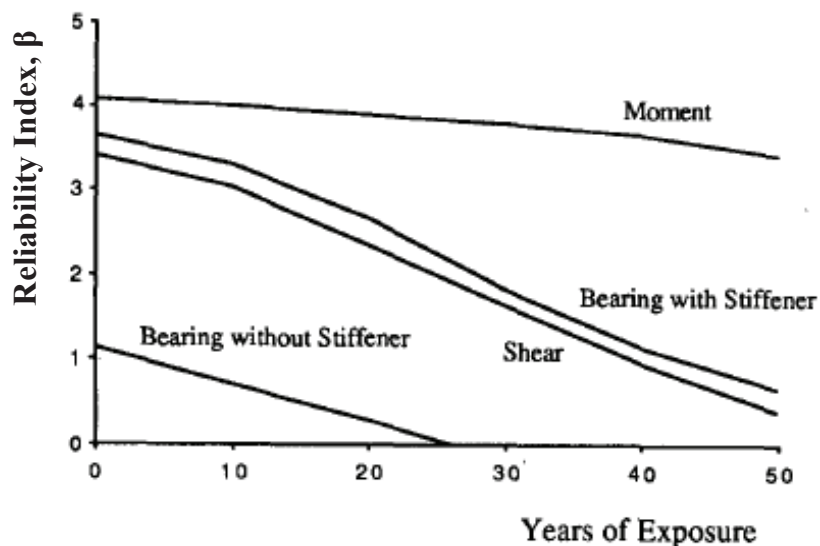
Figure 2.4: Reliability versus time for short Span (12 m) steel bridge

The loss of girder material due to corrosion has more effect on the web than on the flange as clear from the Figure 2.4. This causes a larger percentage decrease in shear and bearing reliability than in bending reliability. He concluded that a surface loss of 2 mm on both sides of the web and on the top of the flange will reduce the web area by 27%, and the flange area by 10%. The web will further be affected by the fact that it acts in compression, subject to buckling, while the flange is in tension. Further, the web being a compression element is the component most susceptible to corrosion loss. This variation in safety loss from one component to another, or from one mode of resistance to another means that resistance criterion which governs when a bridge is new may not governs when a bridge becomes corroded.

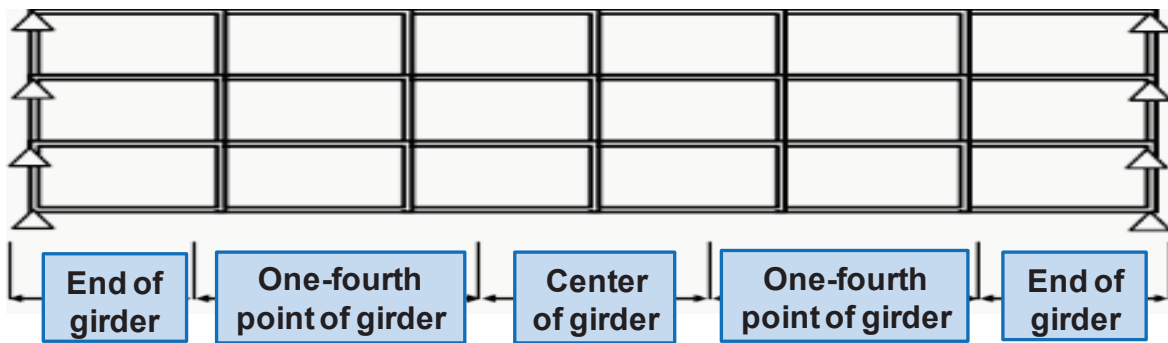
Figure 2.6: Subdivision of plate girder for damage identification

Tamakoshi (2006) studied the locations of corrosion damages on non-composite and composite steel plate girder bridges by partitioning the bridge in various divisions longitudinally, included middle support point of continuous girders. He categorized these divisions as, end of girders, one-fourth of span and center of girder as highlighted in Figure 2.6.

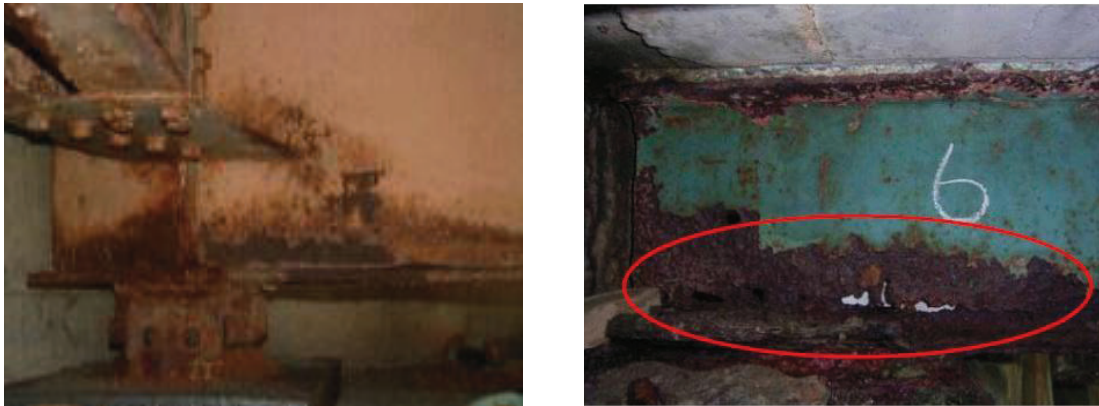
Figure 2.7: Actual corrosion damage cases on plate girder end (Tamakoshi 2006b)

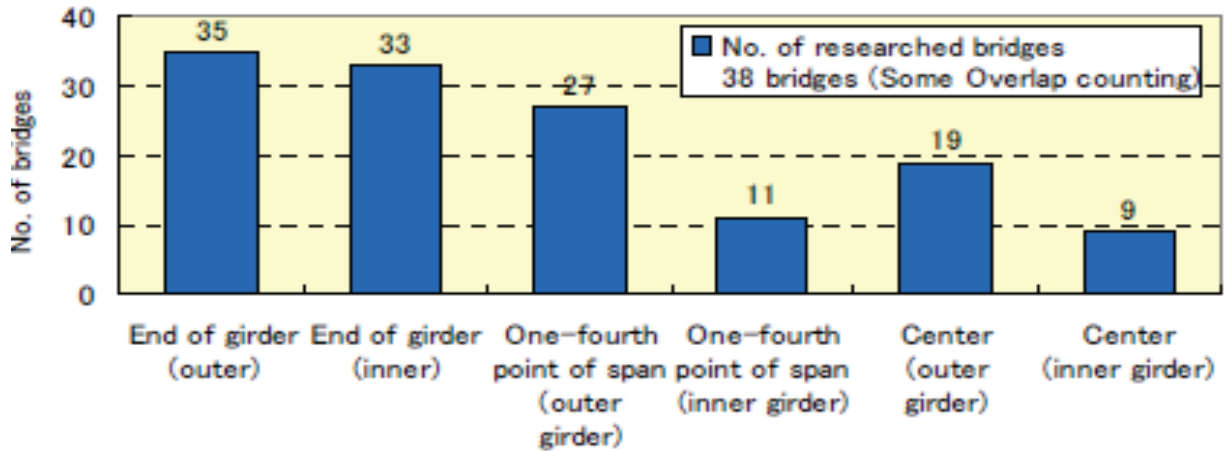
Figure 2.8: Corrosion damages at non-composite steel bridges end

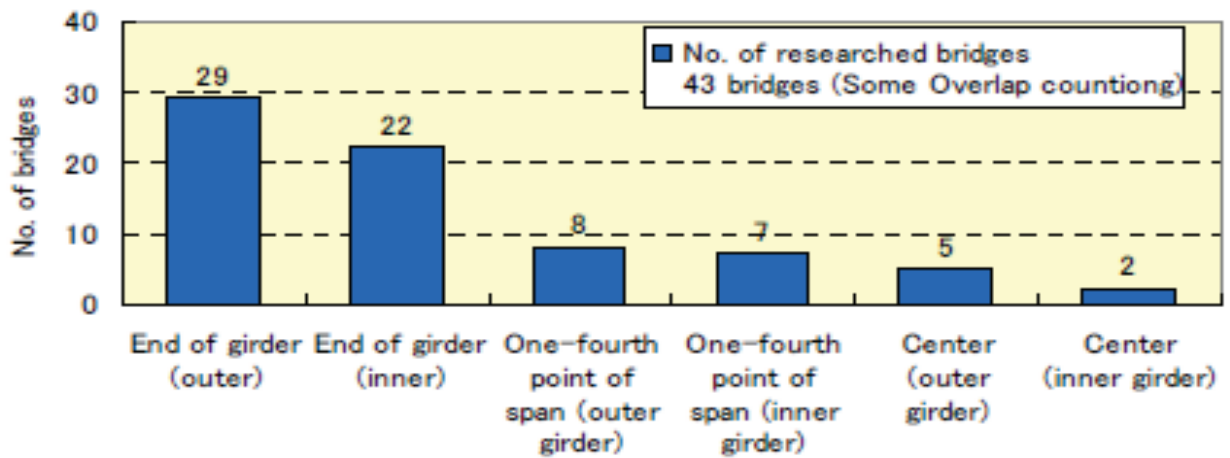
Figure 2.9: Corrosion damages at composite steel bridges end

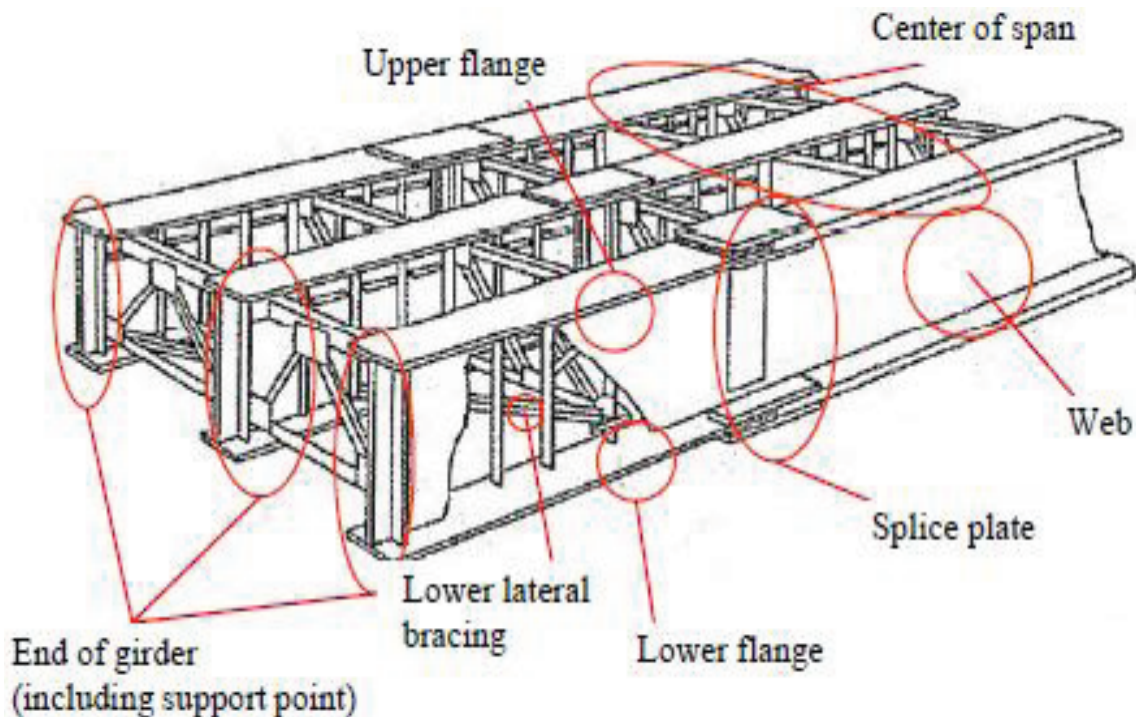
Figure 2.10: Locations of corrosion in the steel bridges in Japan

Besides the corrosions on the web and top flange a significant corrosion was also observed at lower flanges in sections of composite-type plate girder. The rate of lower flange corrosions was 65.1 % of the bridges studied. Further, field observations indicate that newly built bridges, particularly those built using corrosion-resistant steel and/or painted with freeze-resistant coatings tends to corrode locally and thus, comparatively older bridges are likely to corrode as a whole on the span. Figure 2.10 shows the some common locations of the steel bridges suffered by the corrosion.

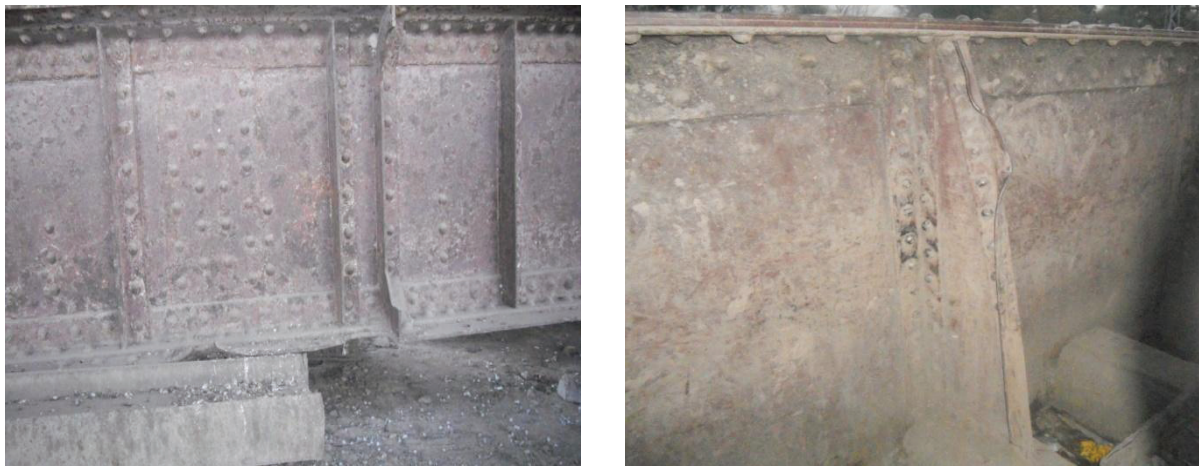
Figure 3.4: The corrosion on the girder due to non-painting

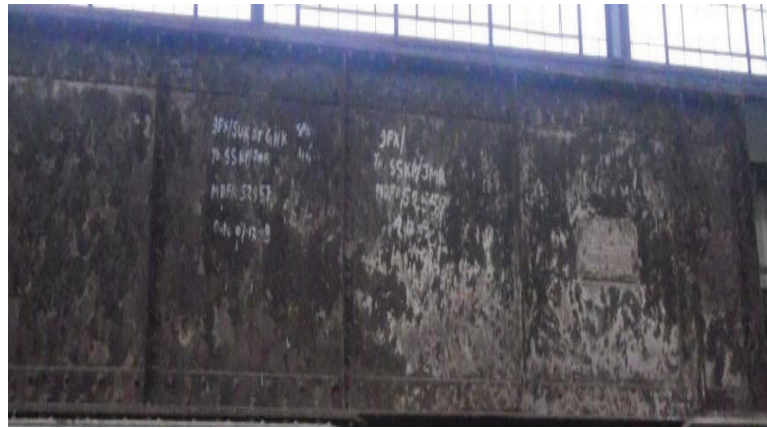
Figure 3.7: Uniform corrosion on steel bridges near sea line areas

Uniform corrosion pattern were generally observed in Karachi city which is near the sea line area and where plate girder are submerged in the water due to high flood level in the river and canals. Near the sea line area usually uniform corrosion was observed on whole bridge surface as shown in Figure 3.7. But in case of the submerged and other plate girder bridges that are exposed to high humidity and elevated temperature are found to be uniformly corroded from the top surface of bottom flange and up to the 1/4 to the 1/6 portion of web from the bottom flange as shown in the Figure 3.8. It is generally accumulation and sticking of the water vapours at the lower web surface in humid and rainy season.

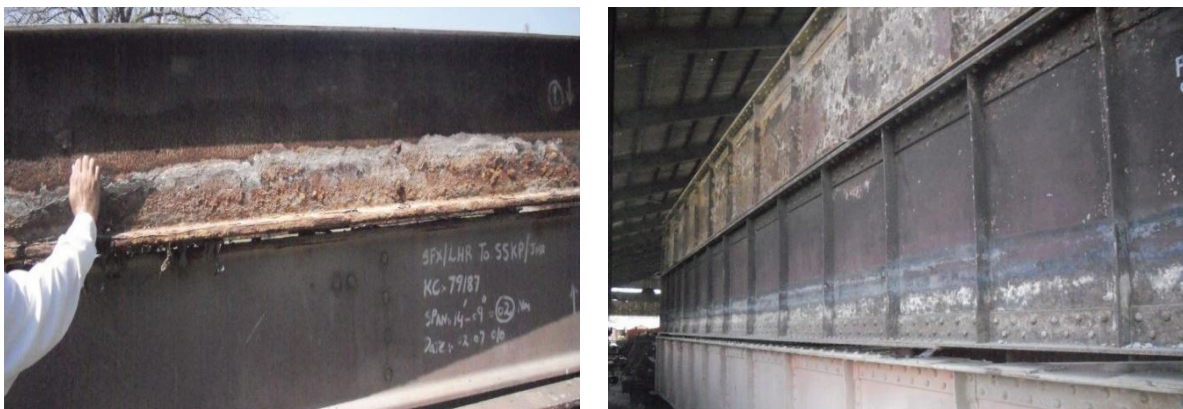
Figure 3.8: Uniform corrosion on the lower portion of web and bottom flanges

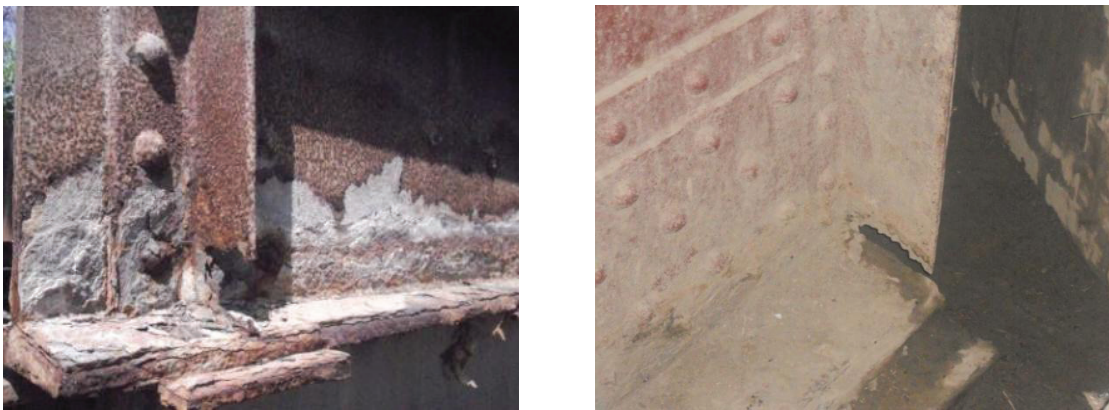
Figure 3.9: Damages at plate girder end due to rain and drainage water accumulation

In many cases local corrosion and pitted corrosion damage were also observed in the field. Usually these types of the damages are more commonly found at bridge ends. Primarily these damages are due to the leakage and accumulation of the water at bearing region in cases of the non through bridges. But in case of through bridges the damages at the end may be due the deposited corrosion and accumulation of the rain water at bridge ends due to the poor drainage conditions. Figure 3.9 shows the typical damages at plate girder end due deposited corrosion and corrosion due to the rain and drainage water respectively. The corrosion damage at plate girder end reduces the thickness of the bearing stiffener and web that may subsequently reduce the bearing and shear capacity of the plate girder.

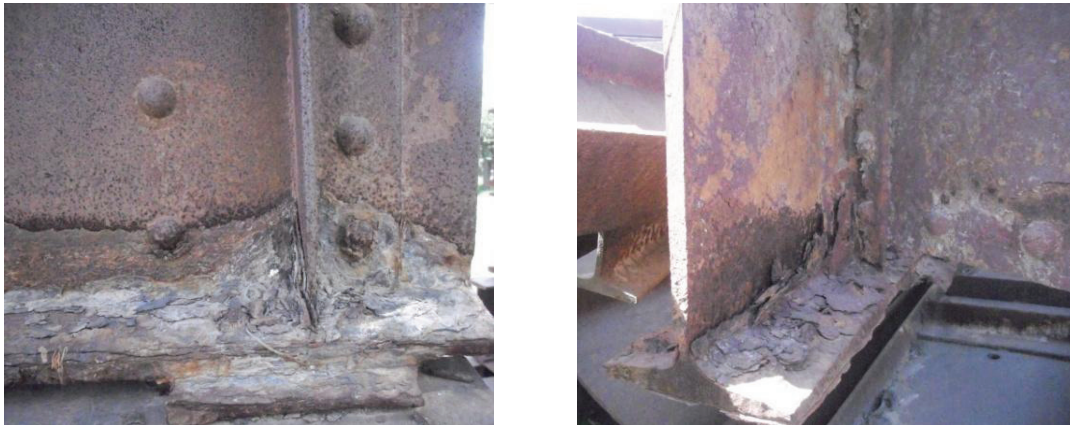
Figure 3.10: Damages at plate girder end due to deposited corrosion

This type of the corrosion occurs when dissimilar metals are connected in the presence of an electrolyte a galvanic corrosion reaction occurs. Electrolytes are electrically conductive solutions such as sea water or road salt spray which contain chloride or rain, mist or dew containing sulfur or nitrogen compounds. The most common sources of chloride contamination are marine and coastal environments as well as winter road salting spray. Sulfur and nitrogen compounds are more ubiquitous being the product of air pollution and industrial fallout. Figure 3.10 shows the some deposited corrosion cases.

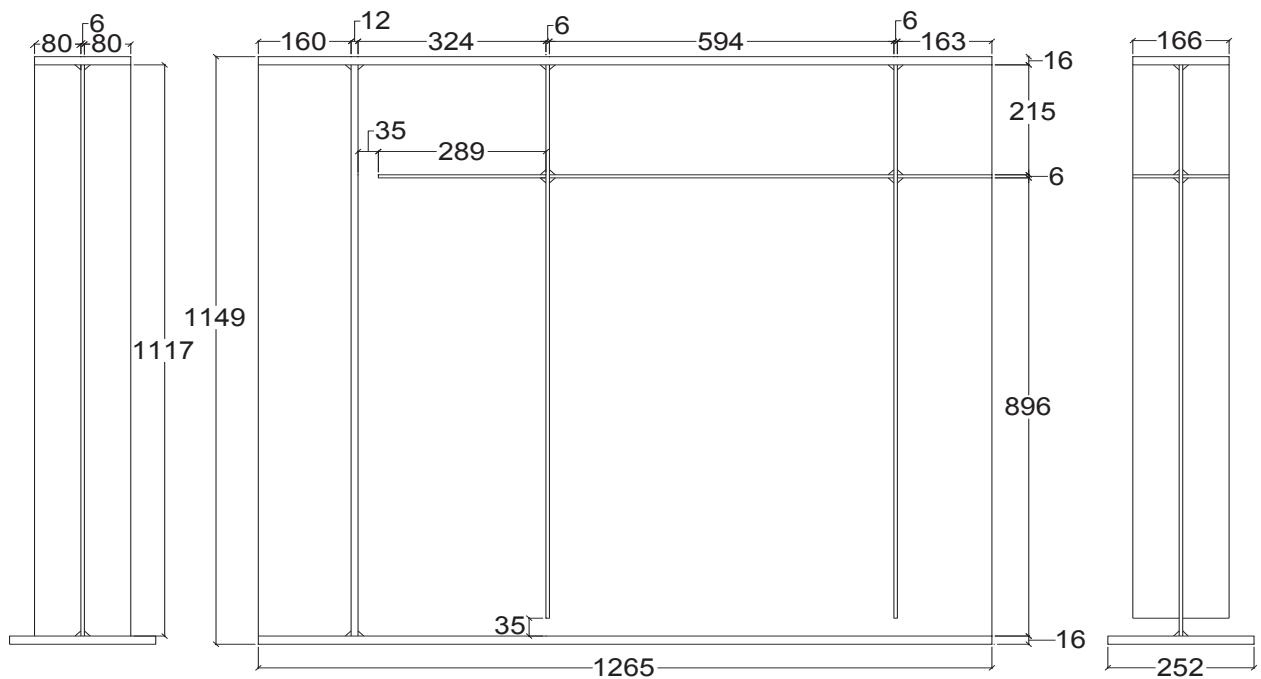
Figure 4.1: Detail dimensions of the test specimen in mm

In the present study, five identical steel plate girder end specimens but with different types of corrosion damage in the bearing stiffener, were utilized in the experimental program. All specimens were designed similar to the actual plate girder from the field used by Hung *et al.* (2002), by picking a reduced scale ratio of two-third ($2/3$). As the primary objective of the study is to investigate the corrosion effect on bearing capacity, thickness of bearing stiffener was set to 12mm and thickness of web and intermittent stiffener were fixed to 6mm. A relatively large thickness, 16 mm was chosen for the flanges to reduce the punching effect during the load application of concentrated compressive load. In all welds a leg length of 5mm was applied. The detail dimensions of the test specimen are illustrated in Figure 4.1.

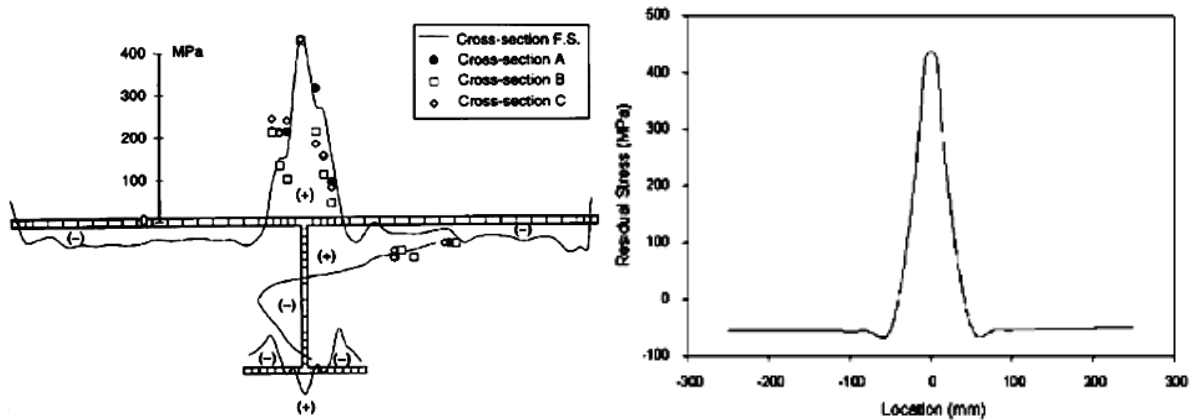
Figure 5.7: Residual stress distribution in the stiffened Panel (SCC-399, 1997).

Residual stresses in rolled steel sections are mainly caused by uneven cooling after rolling and in built-up sections fabricated by welding together several plates, the residual stresses are caused by the shrinkage of the material adjacent to the weld. Welding or flame-cutting induces very high temperatures in a localized strip. Shrinkage due to cooling of this strip is resisted by the remaining cold portion of the steelwork. As a result, the strip adjacent to the weld or flame cut is subjected to high tensile strains which may be several times the yield strain, and the rest of the steelwork is subjected to compression (SCC-399, 1997 and Chatterjee, 2003). A typical residual stress pattern in welded stiffened panel is shown in Figure 5.7.

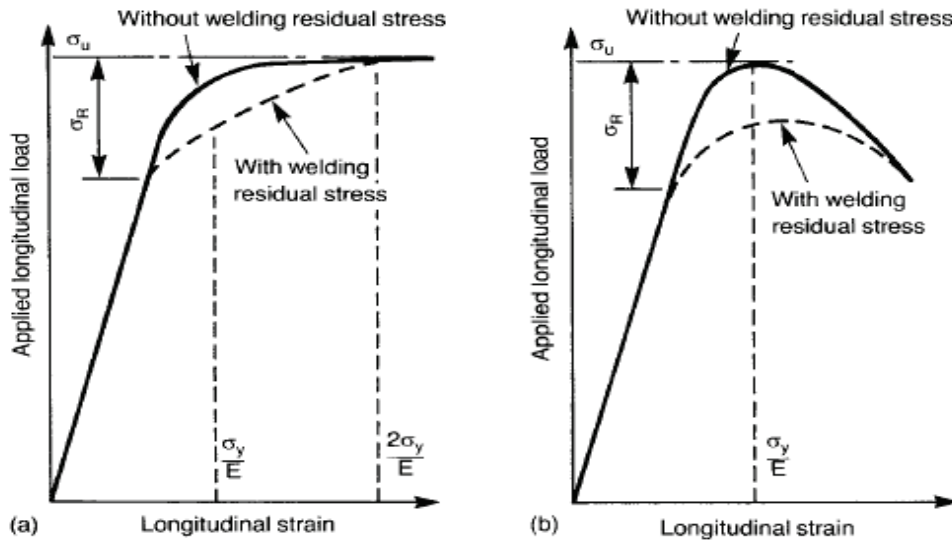
Figure 5.8: Behaviour of plates in compression, with and without welding residual stress.

For the strength of plate panels in compression the important question is whether the plate panel, in a residual-stress-free condition, behaves in a stable or unstable manner when the axial straining is continued after it reached its maximum capacity. This is described in Figure 5.8. For the case of plate (a), in the residual-stress-free condition the plate continues to sustain the peak load σ_u when further strained. The same stiffened plate cross-section with welding residual compressive stress σ_R deviates from its initial primarily linear behaviour at an applied stress $(\sigma_u - \sigma_R)$, but with further applied strains reaches an ultimate load σ'_u which is almost the same as or just below σ_u .

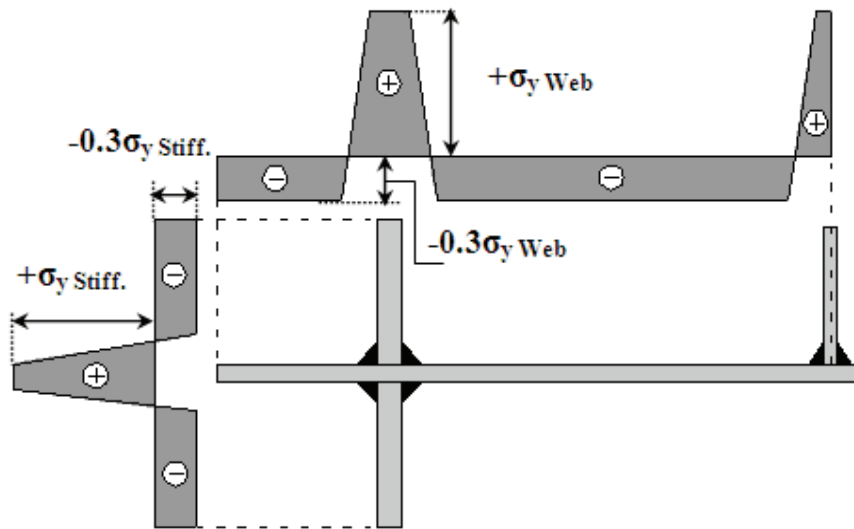
Figure 5.9: Typical welding residual stresses in the plate girder end

The inclusion of residual stresses is very important for the welded structures, especially when they are tested against compression as they cause immature yielding and loss of stiffness (Fujikubo 1999). Usually an idealized residual stress field composed of a tensile rectangular block in the welded region and two compression stress blocks each on the both sides of the welded region is used in the numerical analysis. The Figure 5.9 shows the simplified distribution of the residual stresses in the plate girder. In this particular study, tensile residual stresses equal to the yield stress and compressive stresses equal to the 30% of the yield stress were assumed as suggested by other researchers and specification (Hung *et al.* 2002, Guidelines of the buckling design 2005). The precise distribution of desired residual stresses was generated by the thermal stress analysis. For this purpose, a combination of the negative and positive temperature field in the welded and the other plate regions was applied, respectively. After trial and error process the positive and negative temperature are fixed as $75\text{ }^{\circ}\text{C}$ and $-142\text{ }^{\circ}\text{C}$ respectively, to produce the desire residual stresses the coefficient of thermal expansion was assumed equal to the $11.0 \times 10^{-6}\text{ K}^{-1}$.

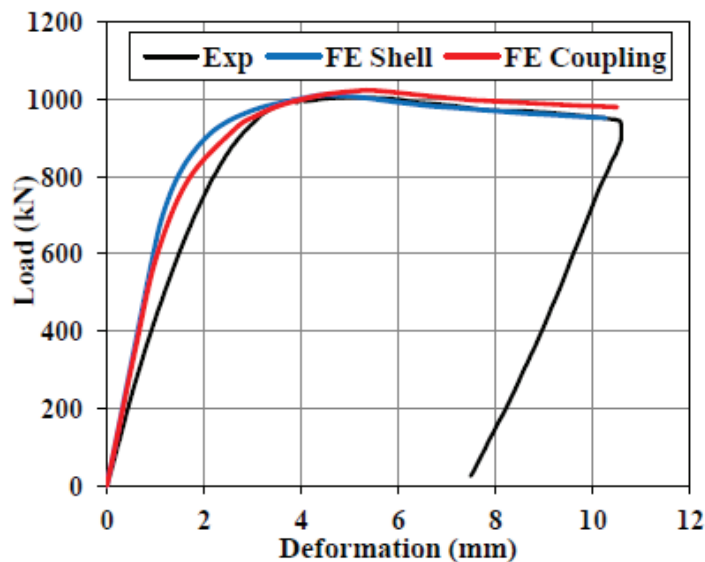
Figure 5.10: Verification of load-displacement curve of healthy specimen

In the analysis, the peak load is almost the same in both healthy and damaged specimen as obtained from the experimental results. However, the initial stiffness is a little higher both in the shell-solid coupling and shell model as can be seen from the Figure 5.10. The welded structures under the axial compressive loading usually exhibit such difference in the initial stiffness due to the precise consideration of the residual stresses. The similar difference was also found in the study conducted by some other researchers like Hung *et al.* (2002). Due to less flexibility and not consideration of the stresses in out of plane direction the shell elements formulation provides a relatively higher initial stiffness than the shell-solid coupling model. As in this particular study, ultimate capacity against buckling is the main concern therefore, initial stiffness may be ignored. Figure 5.11 illustrates that both the shell and shell-solid coupling model demonstrated the identical buckling mode in web and stiffener as of the experimental specimens.

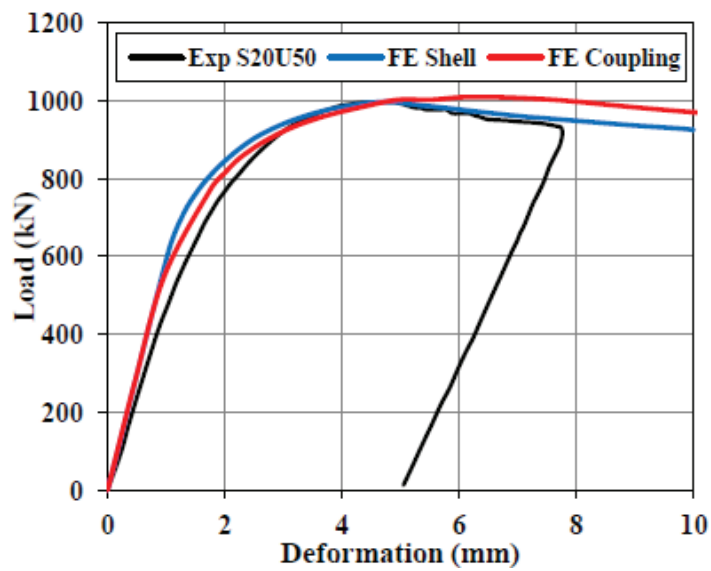
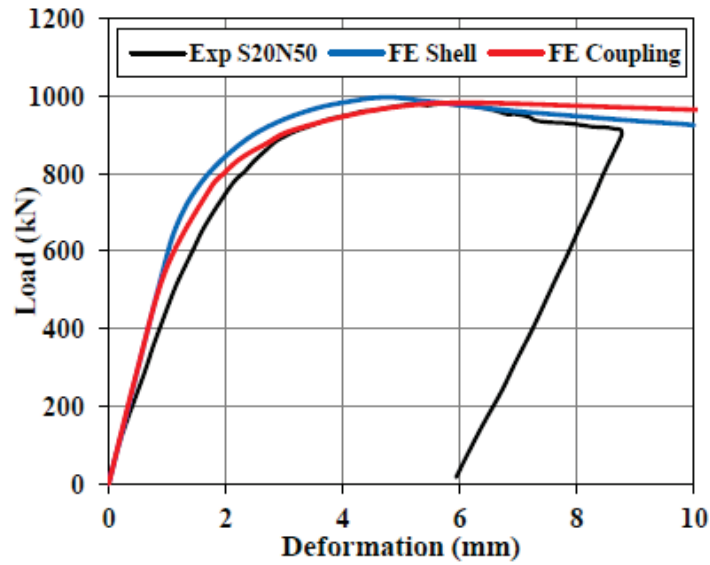
(a) Uniform damage, S20U50

(b) Non-uniform damage, S20N50

The verification of load-displacement curves of both uniform and non-uniform damage with 20mm height is presented in Figure 5.12 where analytical results show the good agreement with the experimental results. Moreover, failure modes obtained from shell and shell-solid coupling formulation are also consistent with tested specimens as shown in Figure 5.13 and Figure 5.14.

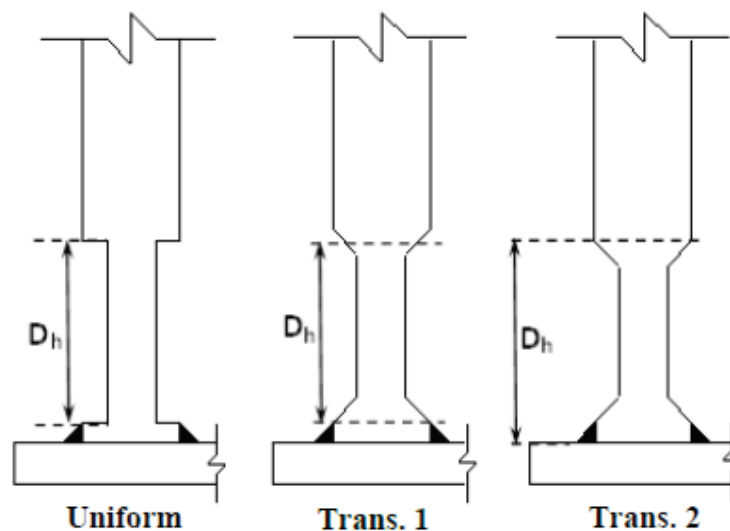
Figure 5.18: Different trail damage shapes

In real cases corrosion yields irregular damages on the steel structure however, for the simplicity a regular and uniform type of the damage is usually incorporated in the FE simulation. Ok *et al.* (2007) used a rectangular shaped corrosion damages in his study for the concentrated pit corrosion. He used this effective cross-section by believing that ultimate strength of corroded plate under uniaxial compression is influenced by the smallest cross section. However, for the further clarification of simple damage shape, three different damage cases as described in Figure 5.18 were used with 50% section loss for all the damage heights considered in the study. In the damage case Trans.1 the damage height is considered from center to center of the transition zones whereas, in Trans.2 the damage height was considered from the edge of the transition zones at thicker part as marked in Figure 5.18.

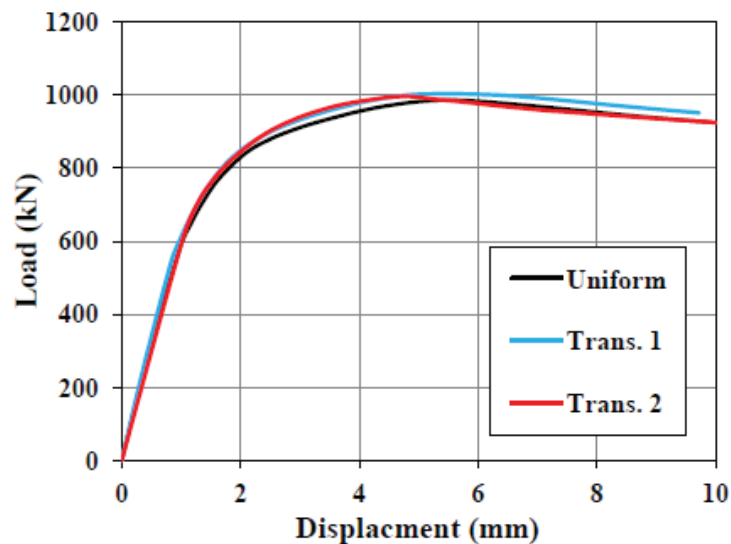
Figure 5.20: Load-displacement curves of different damage shapes for $D_h = 20\text{mm}$ with 50% section loss

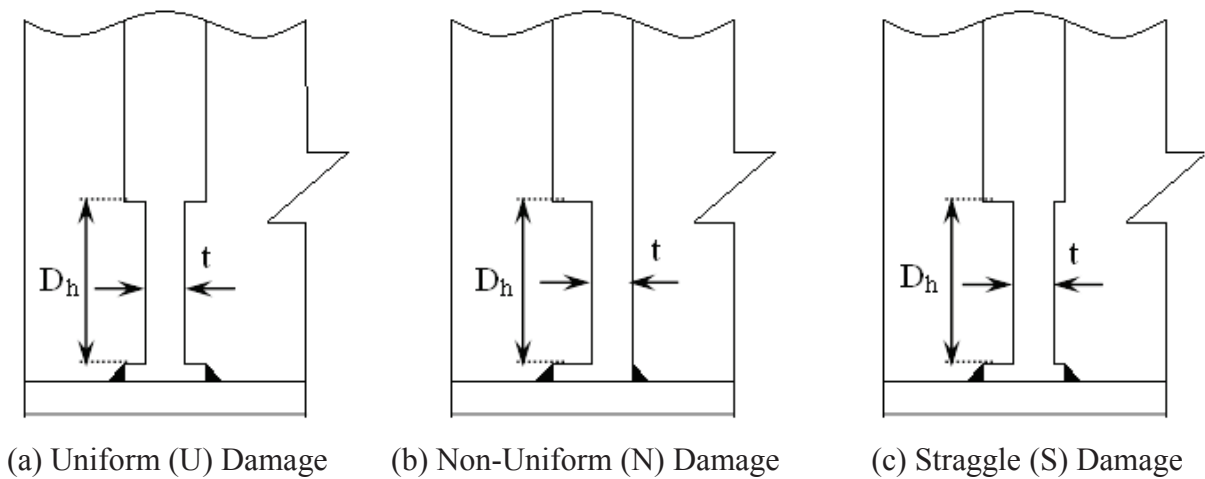
Figure 5.21: Various damage forms considered in the study

As corrosion highly depends on the exposure conditions and it may proliferate into thickness, either from one or both side of the section. Thus, the residual thickness within any corrosive damage may be uniform, non-uniform or straggle in nature as highlighted in Figure 5.21. These different damages forms, possessing the same damage height may exhibit the different behaviour of load-displacement relationships. To clarify the effect of various damage conditions, there different damage forms as mentioned in Figure 5.21 are studied for the all the analytical cases mentioned in Table 5.2.

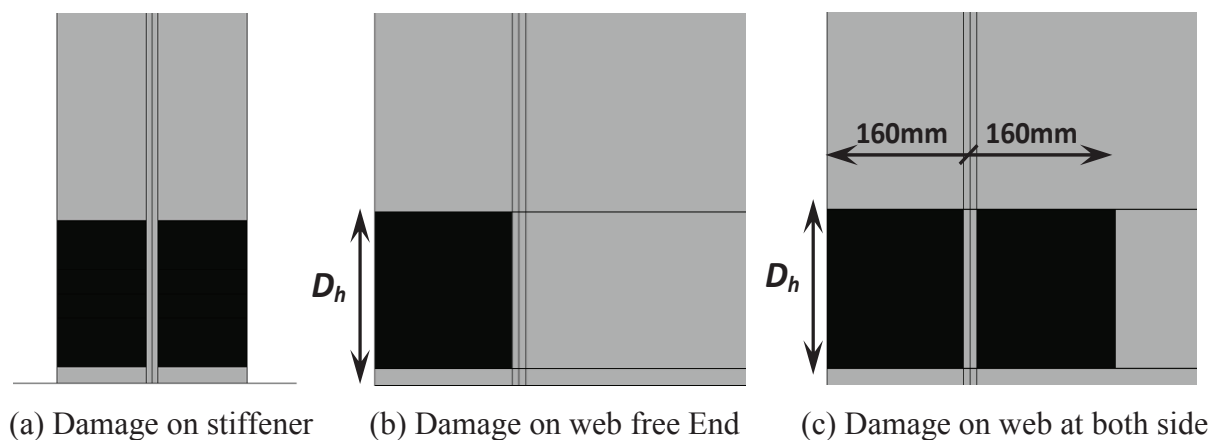
Figure 5.27: Various damage cases considered in the study

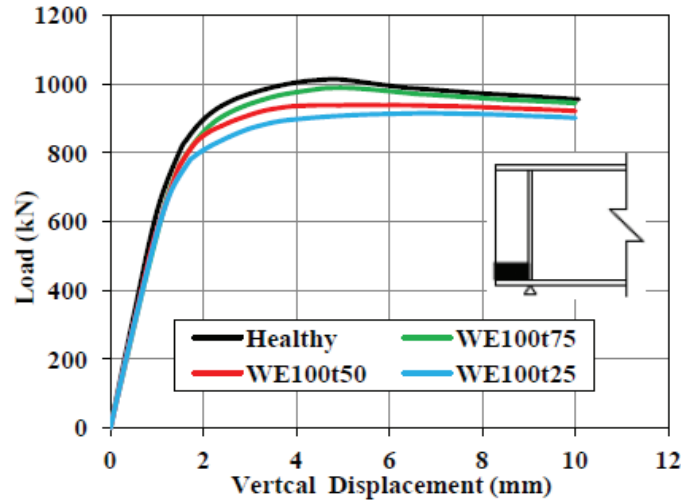
Figure 5.28: Effect of exterior web damage on bearing capacity

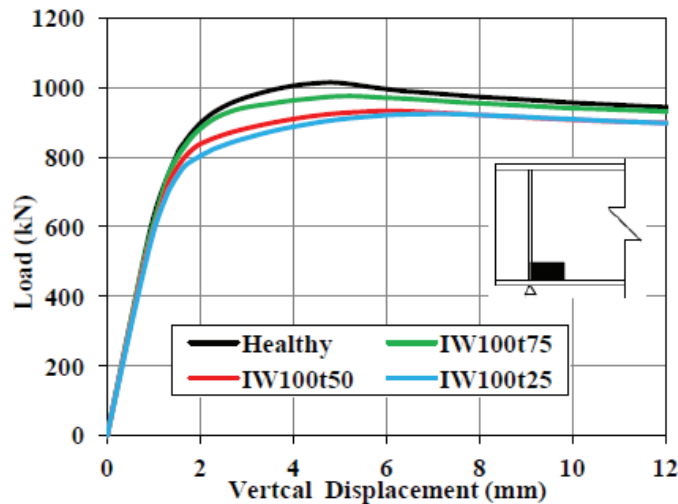
Figure 5.29: Effect of interior web damage on bearing capacity

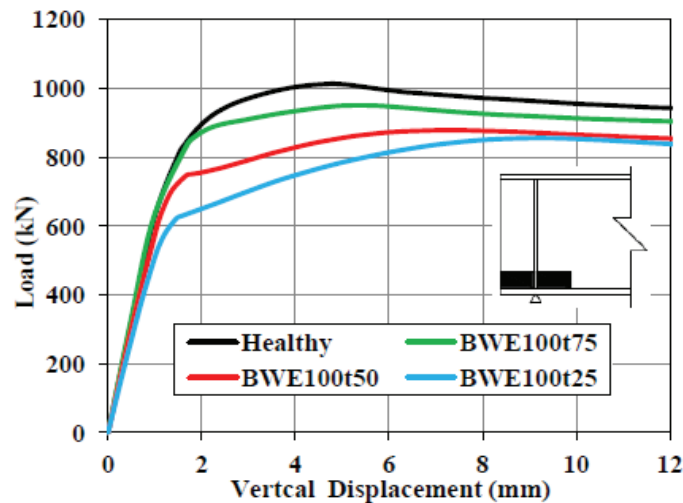
Figure 5.30: Effect of web damage at both side of stiffener on bearing capacity

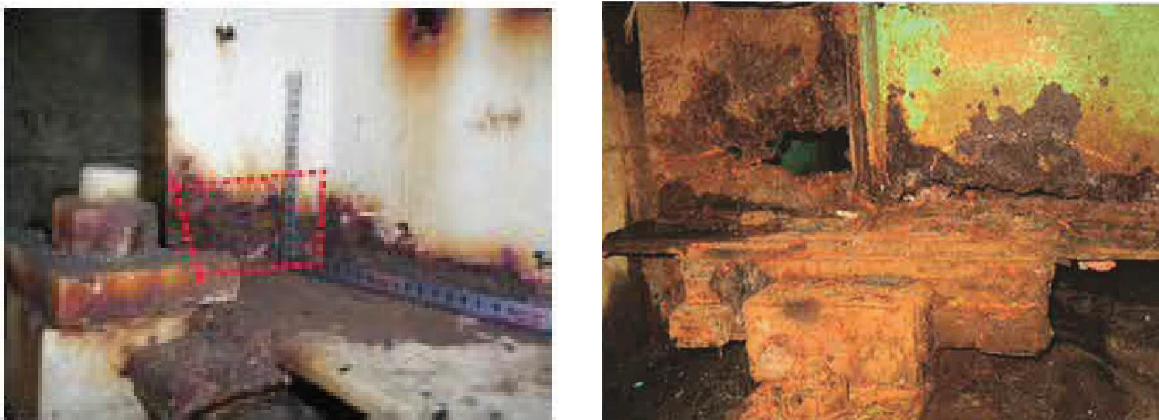
Figure 6.1: Typical corrosion damages at plate girder end by Tamakoshi (2006b)

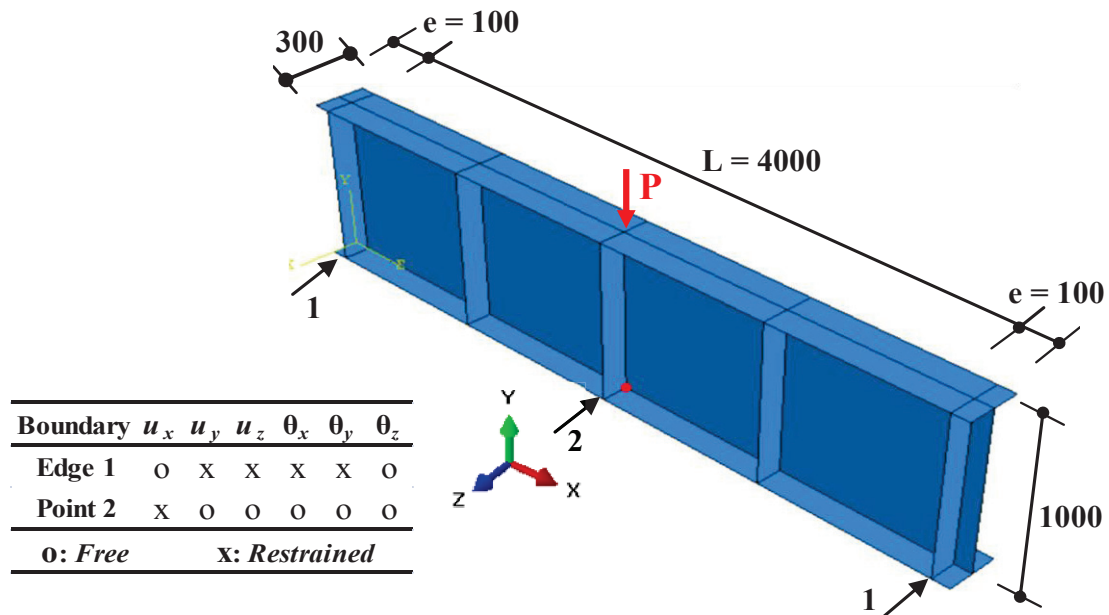
Figure 6.4: Detail dimensions of the girder model (Dimensions are in mm)

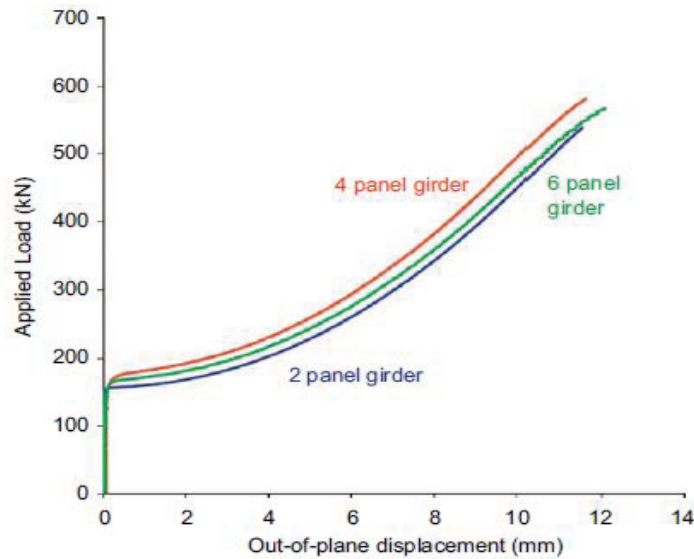
Figure 6.5: Correlation between plate girders with different panels

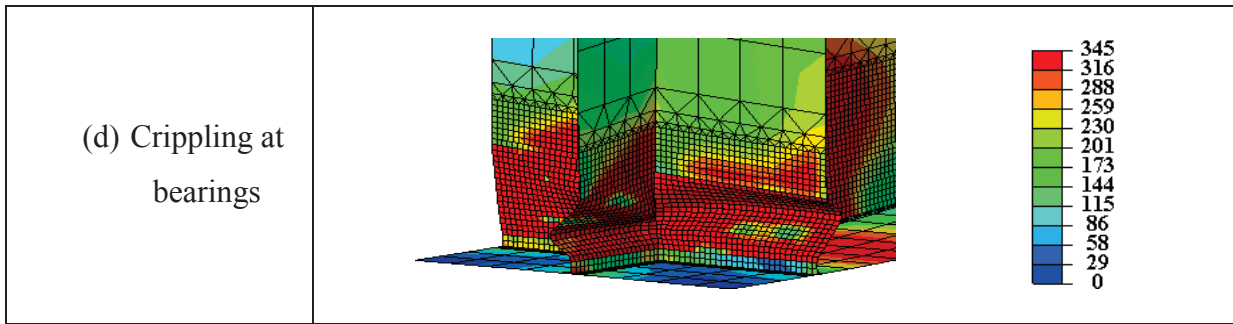
Figure 6.15: Deformed modes for the cases with stiffener plus exterior web damage

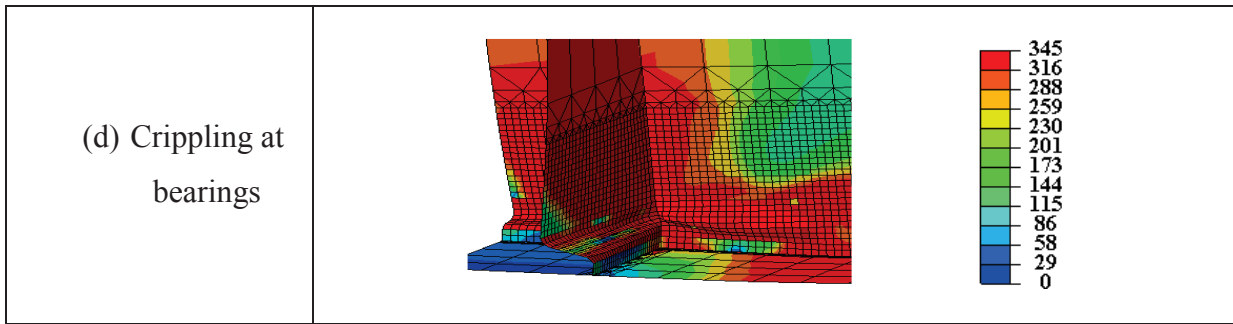
Figure 6.19: Deformed modes for the case with stiffener plus both sides web damage

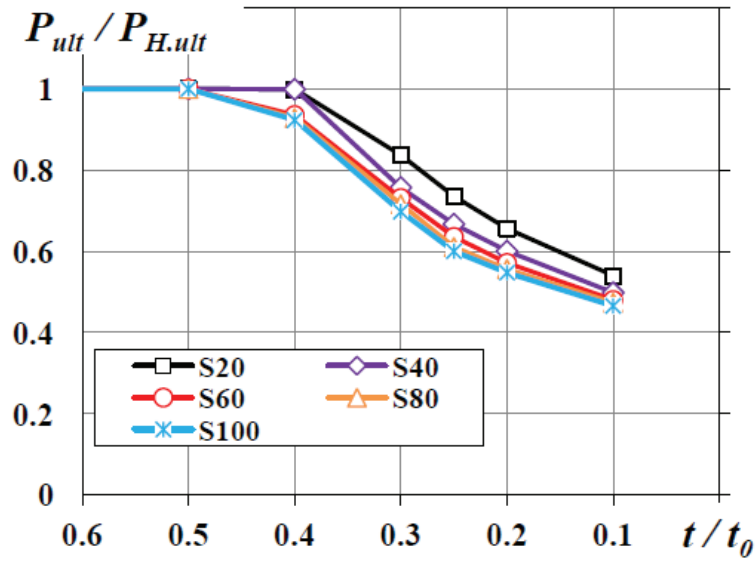
Figure 6.20: Remaining capacity of specimen with stiffener damage

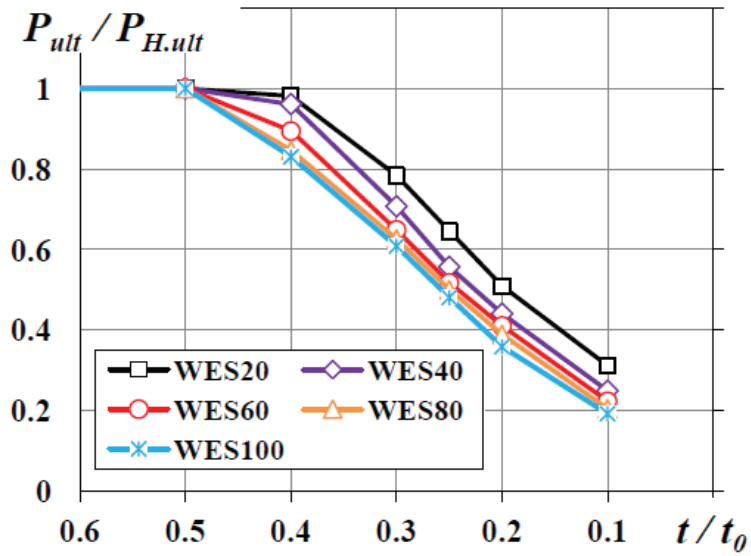
Figure 6.21: Remaining capacity of specimen with stiffener plus exterior web damage

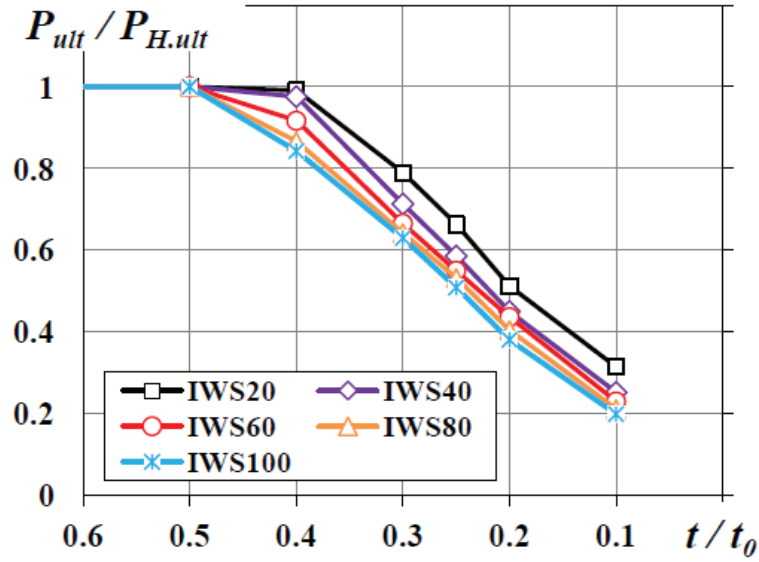
Figure 6.22: Remaining capacity of specimen with stiffener plus interior web damage

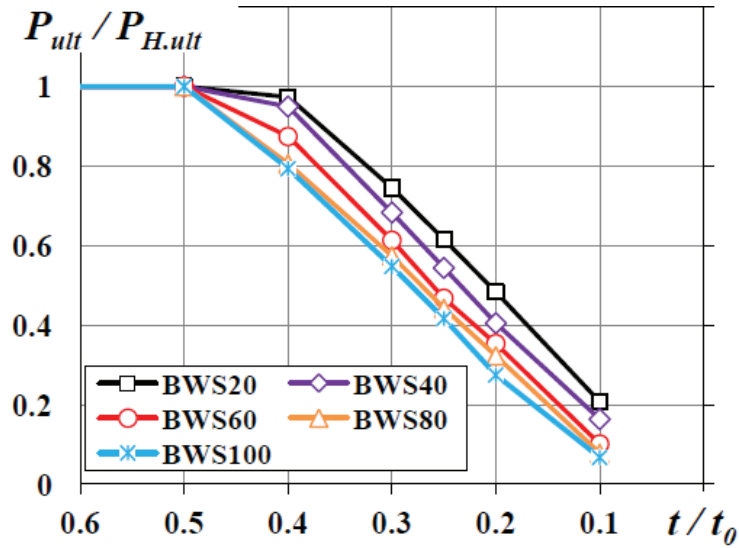
Figure 6.23: Remaining capacity of specimen with stiffener plus both sides web damage

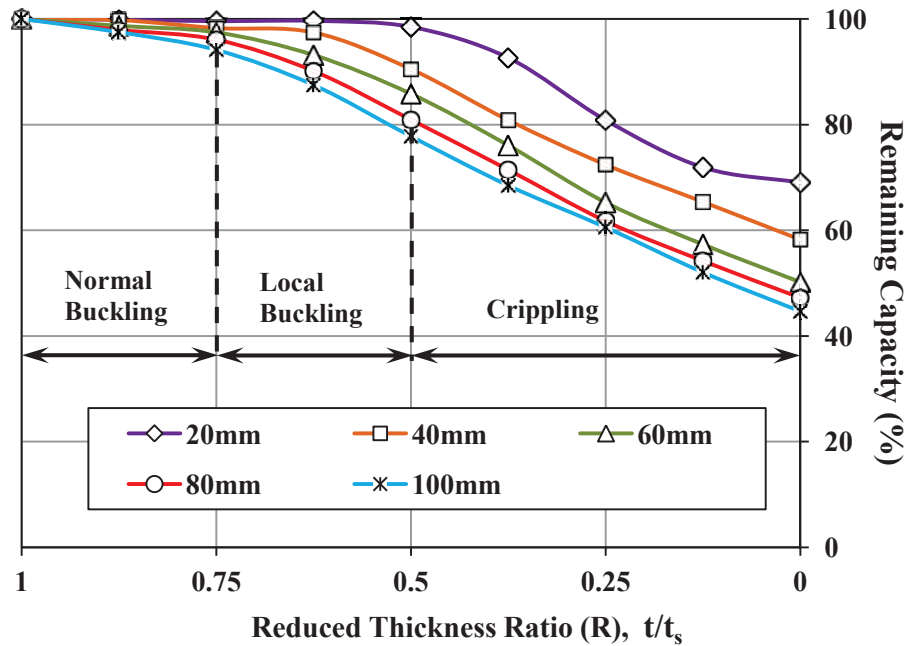
Figure 7.1: Remaining capacity versus reduced thickness ratio

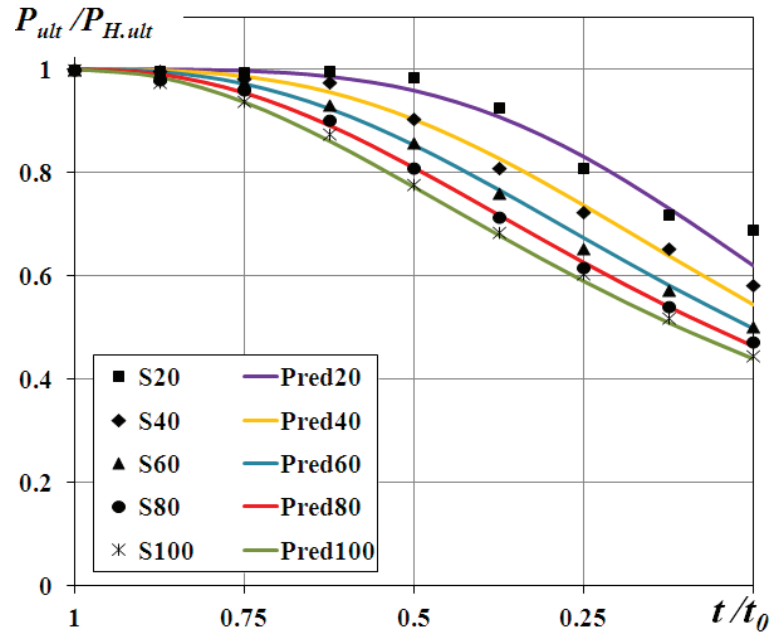
Figure 7.2: Comparison of ultimate shear capacities determined analytically and by empirical formula with stiffener damage

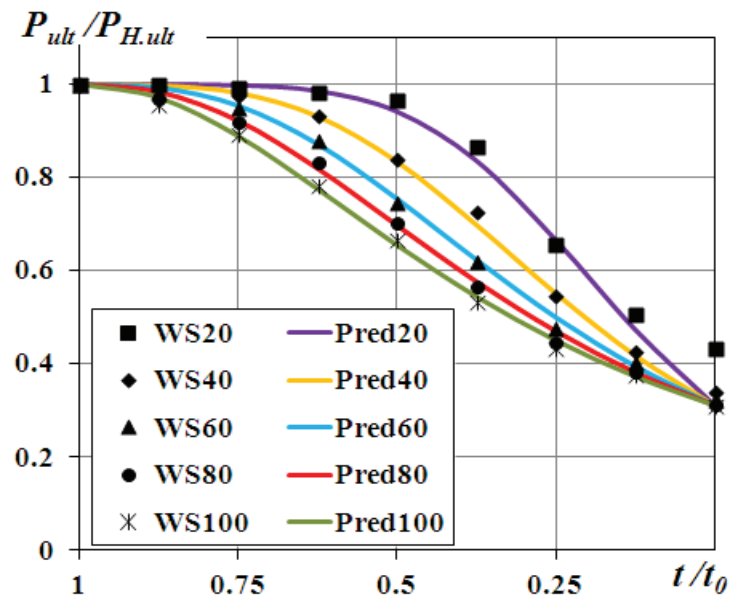
Figure 7.4: Comparison of ultimate bearing capacities determined analytically and by empirical formula with stiffener plus web damage
